DEPARTMENT OF TRANSPORTATION

Contract #: 04-0120F4Cty: SF/ALA Rte: 80 PM: 13.2/13.9File #: 69.28**WELDING INSPECTION REPORT****Resident Engineer:**Siegenthaler, Peter**Address:** 333 Burma Road**City:** Oakland, CA 94607**Report No:** WIR-024012**Date Inspected:** 25-Apr-2011**Project Name:** SAS Superstructure**OSM Arrival Time:** 1500**Prime Contractor:** American Bridge/Fluor Enterprises, a JV**OSM Departure Time:** 300**Contractor:** Zhenhua Port Machinery Company, Ltd (ZPMC), Changxing Island **Location:** Shanghai, China**CWI Name:** Mr. Li Yan Hua**CWI Present:** Yes No**Inspected CWI report:** Yes No N/A**Rod Oven in Use:** Yes No N/A**Electrode to specification:** Yes No N/A**Weld Procedures Followed:** Yes No N/A**Qualified Welders:** Yes No N/A**Verified Joint Fit-up:** Yes No N/A**Approved Drawings:** Yes No N/A**Approved WPS:** Yes No N/A**Delayed / Cancelled:** Yes No N/A**Bridge No:** 34-0006**Component:** OBG**Summary of Items Observed:**

WELDING INSPECTION REPORT

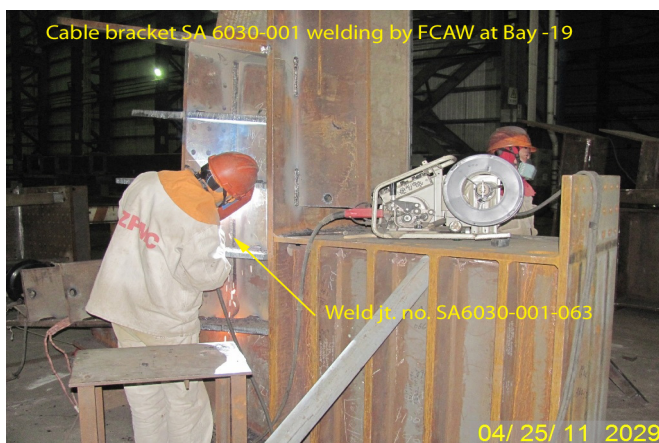
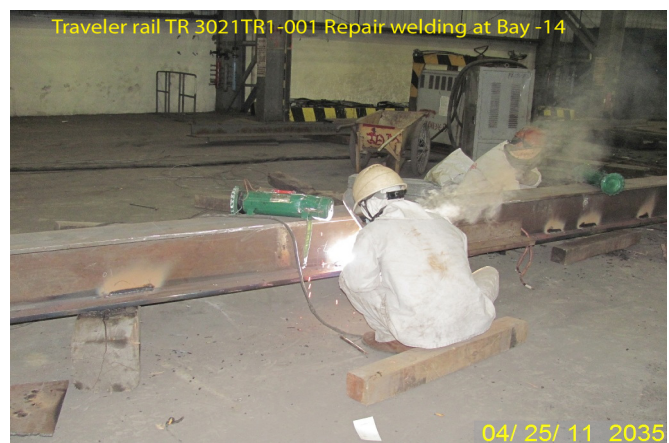
For further information see below pictures:-

Unless otherwise noted, all work observed on this date appeared to be in general compliance with the applicable contract documents.
